# Manhole Inspection Summary

Manhole # S21EE\_009MH

**Location** Address: **1311 MULLIN ST**

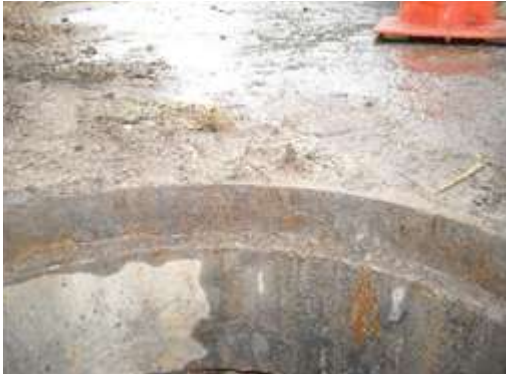
Subject To Ponding: **Sheeting**

SHEETING

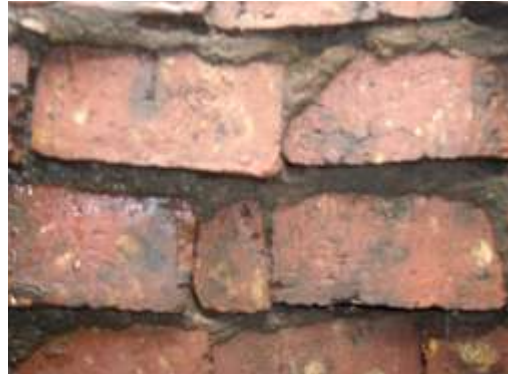
Defect 6

EVIDENCE OF INFILTRATION DUE TO SHEETING

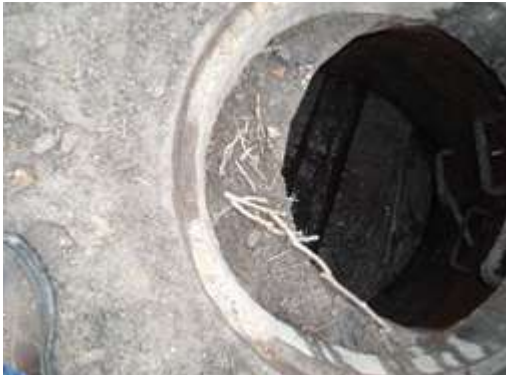
Defect 1

WORN COVER

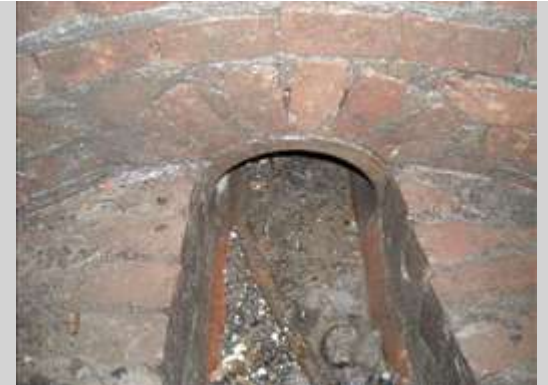
12 O'Clock Outflow

Pipe Height: **7.2** (in.) Rod and Bar (Angled)  
Pipe Material: **Clay** ☐ Pipe Lined  
Invert Depth: **7.37** (ft.) Flow Characteristics: **None**  
Deposits: ☐ None ☐ Mud ☐ Sludge ☒ **Debris** ☐ Grease  
Silt Depth: **1** (in.) Deposits Extent: **Light**  
Infiltration: **None** Pipe Seal Cond: **Sound**

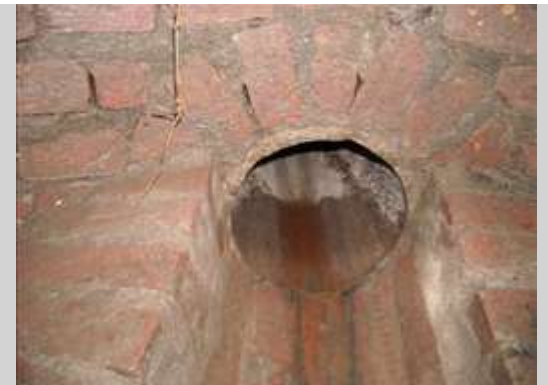
3 O'Clock Inflow

Pipe Height: **8.4** (in.) Rod and Bar (Angled)  
Pipe Material: **Clay** ☐ Pipe Lined  
Invert Depth: **6.86** (ft.) Flow Characteristics: **None**  
Deposits: ☐ None ☐ Mud ☐ Sludge ☒ **Debris** ☐ Grease  
Silt Depth: **1** (in.) Deposits Extent: **Light**  
Infiltration: **None** Pipe Seal Cond: **Sound**

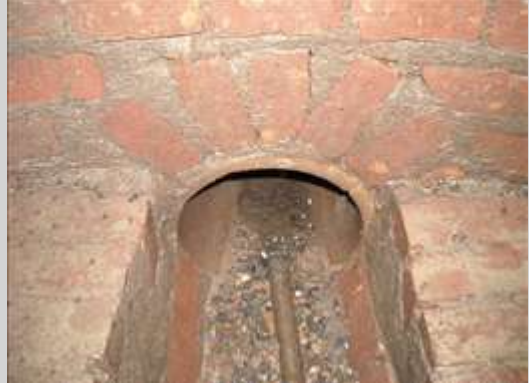
6 O'Clock Inflow

Deposits: ☐ None ☐ Mud ☐ Sludge ☒ **Debris** ☐ Grease

Silt Depth: **1** (in.) Deposits Extent: **Light**
